COASTAL EROSION AND PROTECTIVE MEASURES: A CASE STUDY OF ERNAKULAM COAST IN KERALA, INDIA

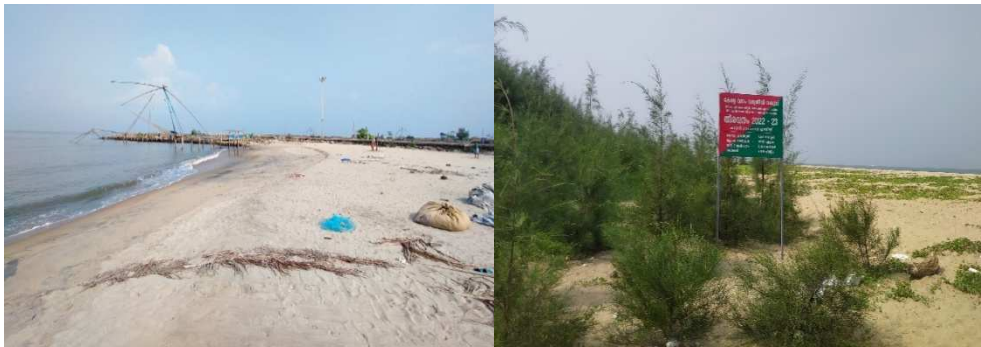
Figure 2: Munambam Beach

One of the longest groynes, locally known as ‘Pulimutt’ (Malayalam) in Ernakulam, is at the opening of Munambam Harbour, the northern tip of the study area. The presence of this groyne at the mouth of the estuary to facilitate fishing harbour has caused the accumulation of beach sand immediately south of it. This resulted in the formation of Munambam recreational beach (figure 2), well-known for various water sports. Another major location of accretion is mainly found north of the Cochin inlet from Elakunnapuzha to Puthuvype. The Social Forestry Division under the Department of Forest and Wildlife, Kerala, have planted Kattadi trees (Casuarina) in the name of the ‘Theeravanam Project’ to protect the accreted beach (figure 3). The plantation covers around 1.5 hectares, and the project is still ongoing. The presence of this artificial forest attracts hundreds of tourists every day during sunset. At Elakunnapuzha Beach (figure 4), the seawall is about 100 meters from the sea, while the vegetation line is only about 30 meters away. Near the Valappu beach, the seawall is located more than 500 m inside the present coastline due to accretion. According to the Centre for Earth Science Studies newsletter, Thiruvananthapuram (2007), a spectacular accretion of about 1.8 km was observed over 15 years at Puthuvype.

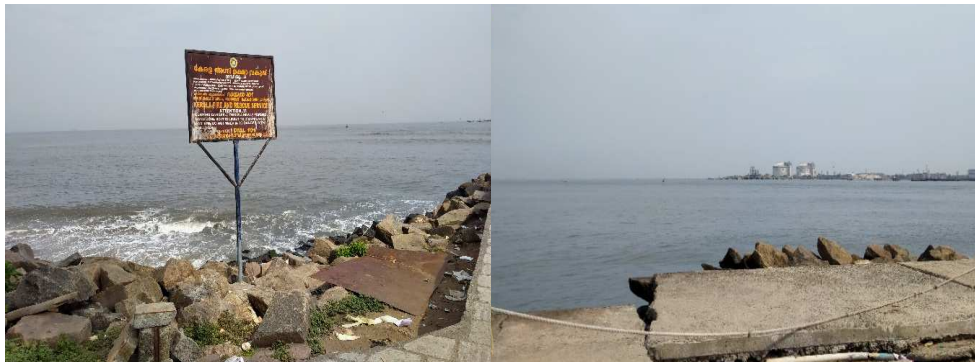
Figure 5: Warning board at Fort Kochi **Figure 6:** Damaged pathways at Fort Kochi

in there to give a warning for entering into the sea. Apart from these unstable sand dunes (figure 5), this sector has no sandy beach. The seawall pathways at Fort Kochi have been identified as destroyed due to the waves (figure 6). During monsoon months (June to September), wave heights are higher in coastal Kerala. Many places in Ernakulam, like Nayarambalam, Manassery and Chellanam, experience wave attacks and erosion during this period. The beach at Manassery experiences continuous erosion though seawalls were constructed many years ago. Such failures of seawalls as protection structures have been reported from some other locations along the Ernakulam coast. After a few years, seawalls could be damaged or collapsed due to continuous wave action (figure 7). When this occurs, the original seawall is replaced by another layer of bigger and better seawall. In Figure 8, we can see the recently added layer of stones to the older stones of the seawall, which became rounded due to wave-induced weathering.

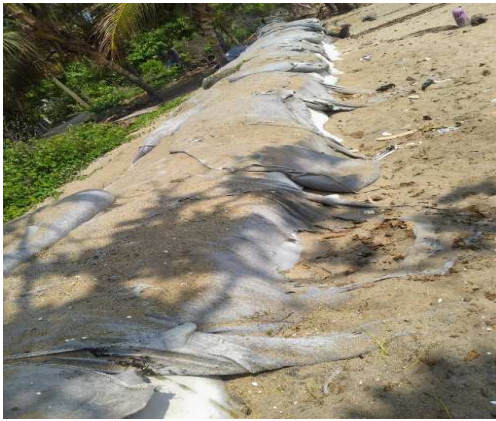
Figure 9: Damaged geobags

Not only the seawalls but groynes and geobags also get damaged in the long term. Geobags, the sand-filled geotextiles, are identified at some stretches like Cherai, Pazhangad and Aniyal Beach. Most of the geobags are completely or partially damaged (figure 9). Figure 10 shows the geobags in Pazhangad Beach, which are found between the seawall and vegetation line. Generally, geobags are provided as a temporary protection measure. This method is very less encouraged in this study area.

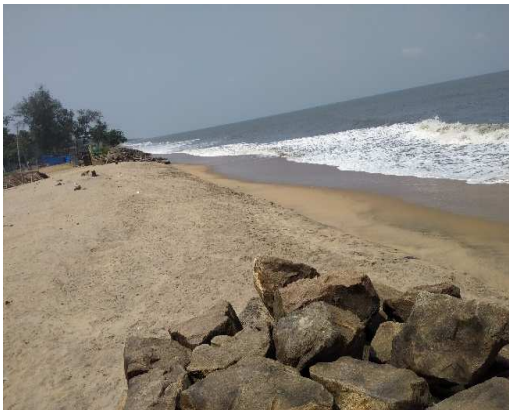
Figure 11: Seawalls with Gaps

The seawall is constructed in certain places with some gaps (figure 11). The small beaches at these gaps are beneficial for local fishermen for fishing and also for landing. However, these gaps in certain places like Beach Road Beach (figure 12) lead to coastal flooding. The sea water entering the land through such gaps is trapped in the settlement area resulting in flooding. In the Manassery-Kannamali stretch, which has experienced a retreating shoreline for the past few years and a very rough sea during every SW monsoon, seawalls are very old and mostly collapsed. Geobags as a means of temporary solution are provided in this area. But it also gets damaged within a few months as the sea is active here. The high waves in this region are attributed to the sand dredging activity at the mouth of the Cochin inlet for the ship channel. Different case studies reveal the major influence of port development on the coastal regions (Kudale, 2010). The main impact of the port development is accumulation on the updrift side of the longshore drift and erosion of the downdrift side. It was reported that there was no erosion earlier south of the Cochin inlet at this rate before the construction of the Cochin Harbour channel. The harbour channel here is a barrier against sediment transport in the area.

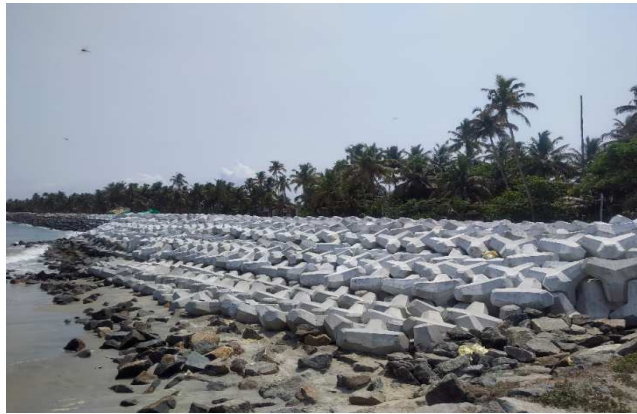
Figure 13: Tetrapod seawall at Chellanam

Chellanam was one of the hotspots of erosion in Ernakulam district. Chellanam coast has experienced significant consequences from tropical cyclones like Okhi (2017). But now, with the construction of the new seawall (figure 13) from Chellanam Harbour to

Puthenthodu, people seem to be relieved from the fear of wave attacks, especially during the monsoon season. With a paved pathway, Tetrapod Seawall is being constructed in this stretch based on the recommendations provided by the National Centre for Coastal Research in Chennai. Construction is partially completed. However, the absence of wave attacks and coastal flooding in the area at the onset of monsoon this year indicates the success of the Tetrapod seawall. The paved pathways with the seawall are the best example of integrating coastal protection into sustainable Tourism. As this tetrapod seawall proved effective, demand arises to extend this project to other places.
