Restoration of Varhala lake by removal of Microcystis bloom through inexpensive methods in Bhiwandi City Maharashtra India.

ABSTRACT:

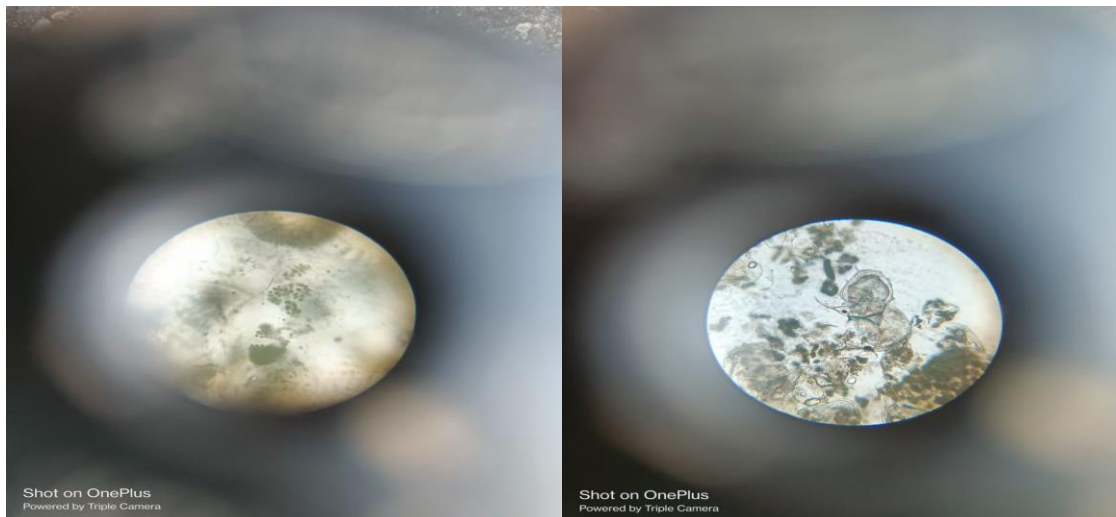
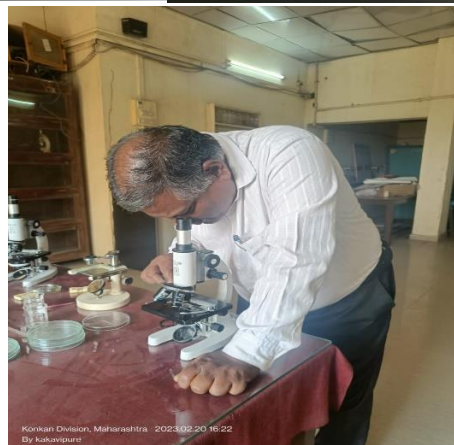
Microscopic examination of lake water showing *Microcystis* and Zooplankton

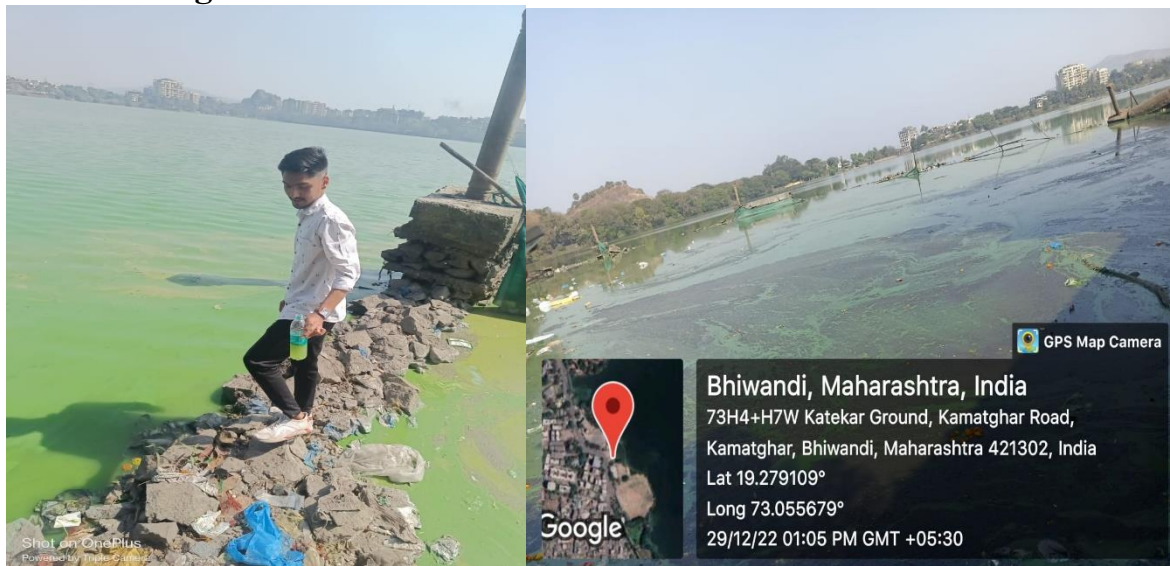
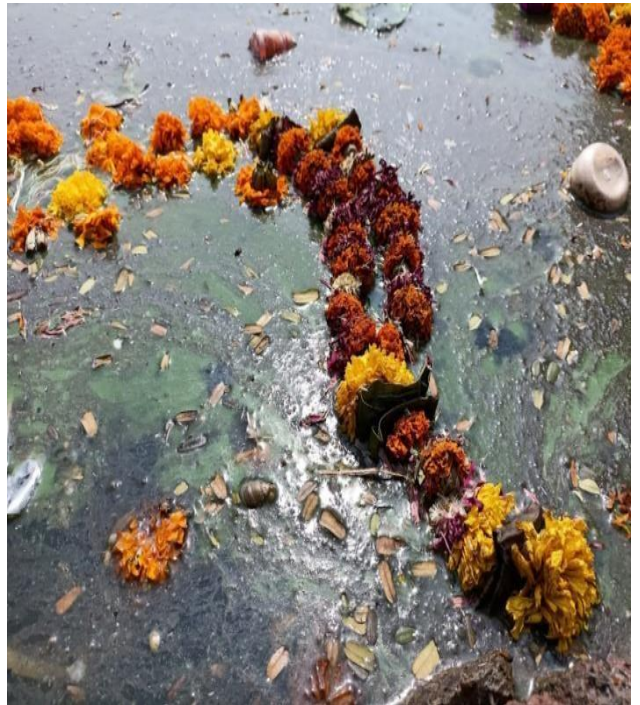
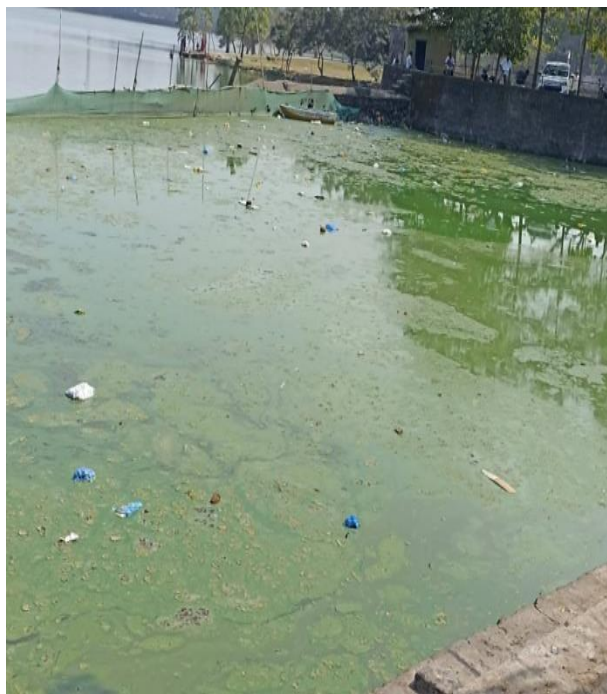
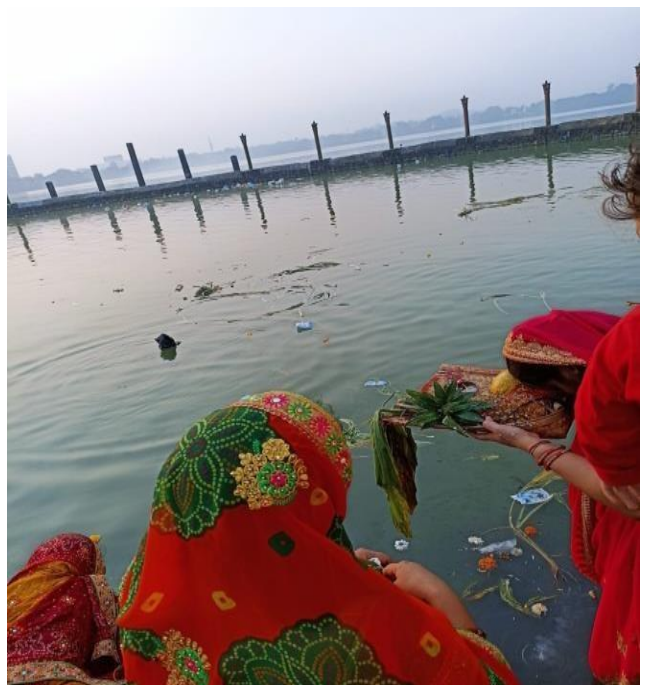
Deteriorating Condition of Lake.

In order to identify the main factors responsible for variations in water quality, increase in Microcystis growth following causes were identified:-

- 1) Heavy siltation
- 2) Non removal of debris accumulated from Ganesh and Durga idol immersion chat pooja, Batkamma and religious waste offered by local communities.
- 3) Non maintenance of equipment install by post NLRCP project like Aerators
- 4) Appropriate climate for growth of micro cystic.

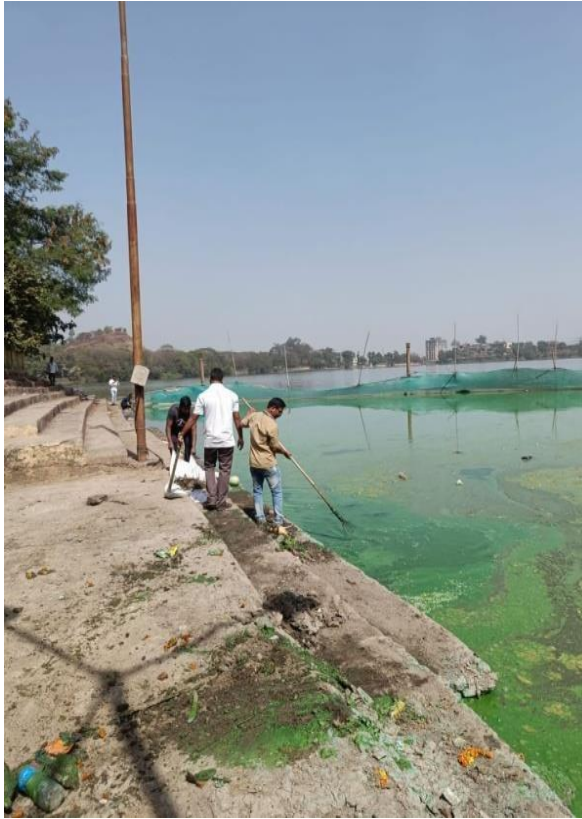
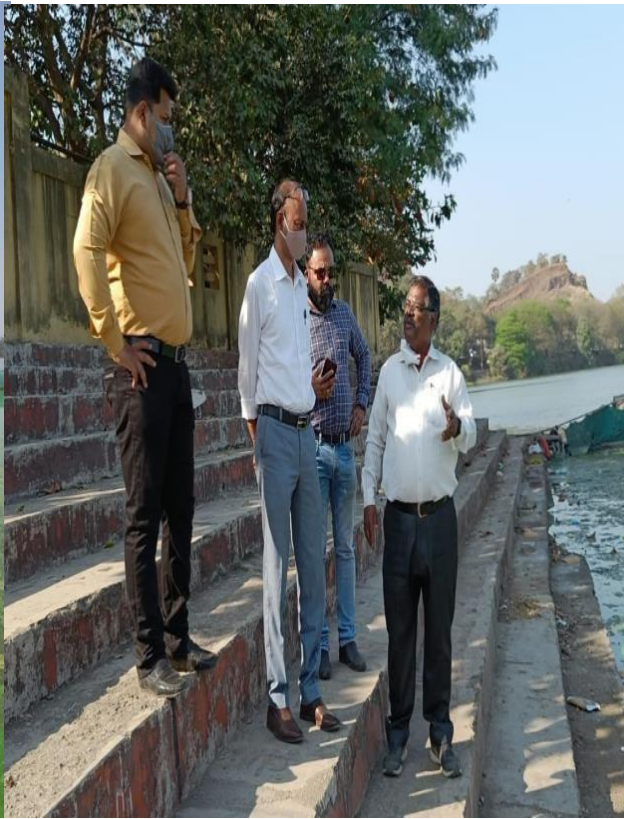
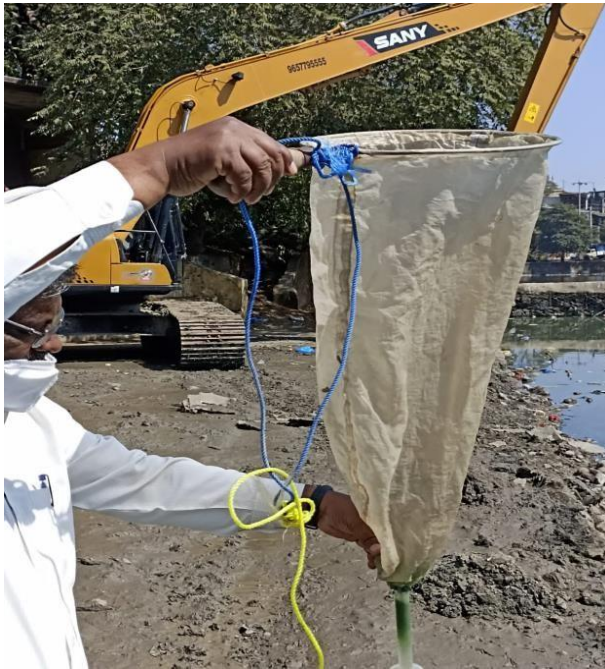
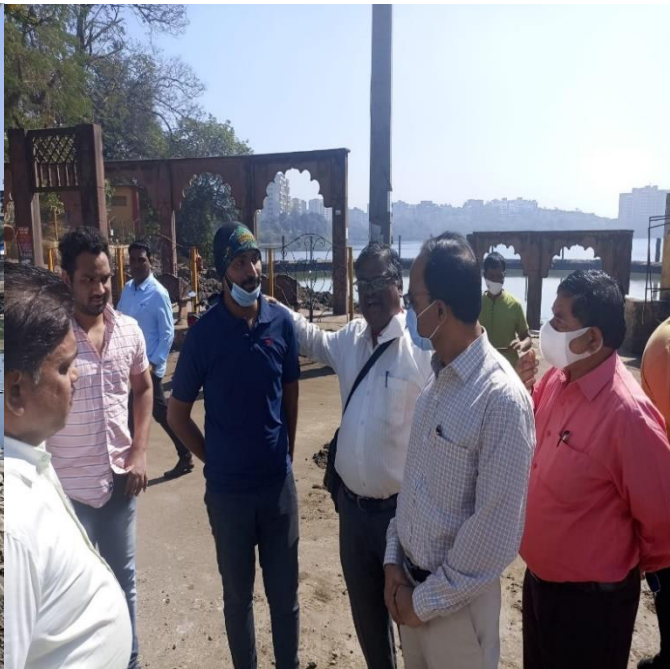
Monitoring Algal bloom with local authorities.

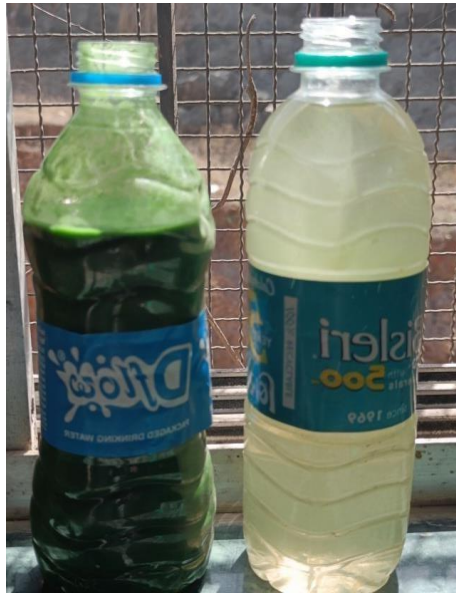
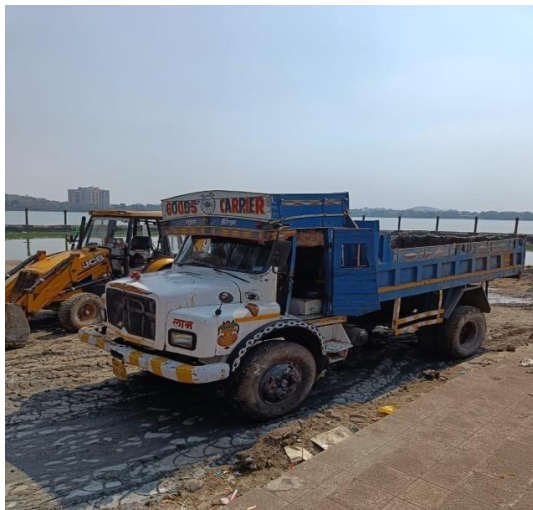
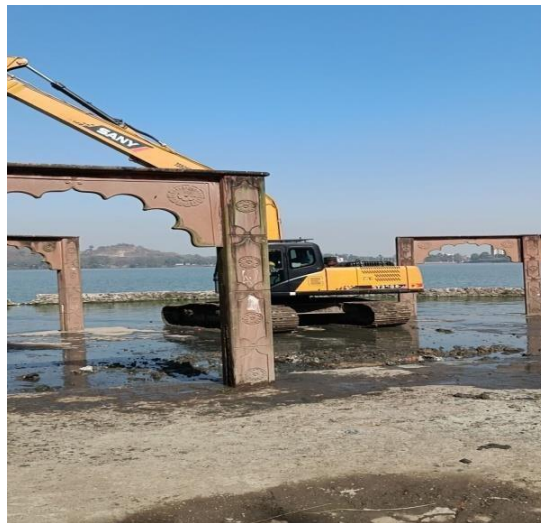
Water Quality Before and After Treatment

Photographs Indicating Manual Removing Debris and Water Sediment with Pock-Lain Machine and Microcystis Scum and Difference of Water Quality Before and After Treatment.

Cyano-L Liquid and Cyanol-Pro Bacteria Commercial Anti Cyano Bacterial Products Available Online. Was Purchased by Municipal Corporation).By Remedial Purpose . Fire Brigade and Health Department Was Called Spreading Sanitization for Killing Superficial Microcystic Scum /Bloom Without Harming Biodiversity. Little Amount Ammonium Aluminum Sulfate, Also Known as Ammonium Alum or Just Alum. Or Alum Was Also Used for Anti- Pursuant Deo- Deront Ammonium Alum Is Not a Major Industrial Chemical or A Particularly Useful Laboratory Reagent, But It Is Cheap and Effective, Which Invites Many Niche Applications. It Is Used in Water Purification.

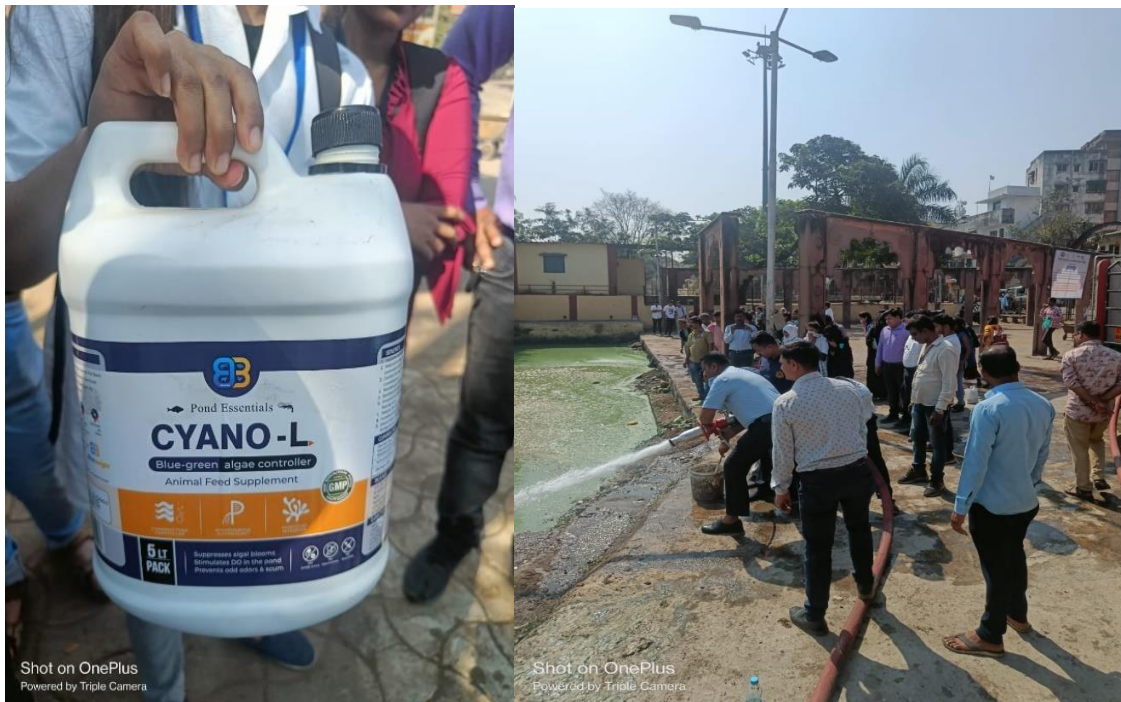
ISOLATED LAKE CONDITION BEFORE TREATMENT AFTER TREATMENT

Lake is Restored to normal before monsoon. Now during monsoon maximum problem is solved. No scum and death of organisms reported. Fisheries is Normal. Water if filtered and treated for the use as potable purpose for Bhiwandi city(5mld.) by adjacent plant. Through Temporary and primary solutions, we able to manage Microcystis bloom and allied problems. It was also observed some fish like Rohu, Catla and Tilapia Which is major carps cultured in this lake was found engulfed large amount of Microcystis along with its normal food Further investigation and its impact on fish physiology is to be studied or investigated. It is also observed that reoccurrence of few zoo and phytoplankton's like Pediastrum, nitzchia, ,keratella , Bos mina, Scenedesmus, rotifers and diatom species were recorded which shows good indication of improvement of ecosystem. For permanent solution for management of lake for such problem long time planning is necessary. Inhibition of sewage water, Construction of damaged boundary wall, Timely removal of debris or bottom sediments, Removal of plastic and other floating debris or waste from surface water, Treatment through proper bioremediation.

Use of Aerators and its Maintenance, Use of NGO and students' participation, Installation of Research lab with proper equipment for day to day or monthly or seasonal data collection and documentation. Purchase of debris and solid waste segregation machine and Use of Funding agencies and MOU with nearby Research Institute , College and to appoint Environmental expertise is recommended to local administration. So that such water bodies can be protected and can form the role models for similar problems in and around. Finally Local awareness campaign for saving this lakes and proper disposal , collection and reusing, recycling and reducing the solid waste management is the need of time. This water bodies are precious, provide health, Wealth and key role in economy. So, let's save them for better tomorrow.
