MRI ARTIFACTS

CLASSIFICATION OF ATRIFACTS

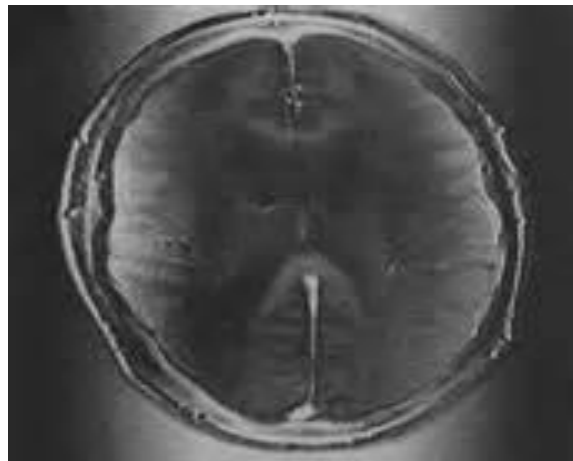
Figure 6 Rf overflow Artifact

CAUSE - this occurs when the signal received by the scanner from the patient is too strong to be accurately digitized using an analog-to-digital converter.

REMEDY– Auto-pre-scan normally adjusts receiver gain to prevent this from happening, but if spurious still exists then receiver gain can be manually reduced. Post-processing methods also exist but can be time consuming.

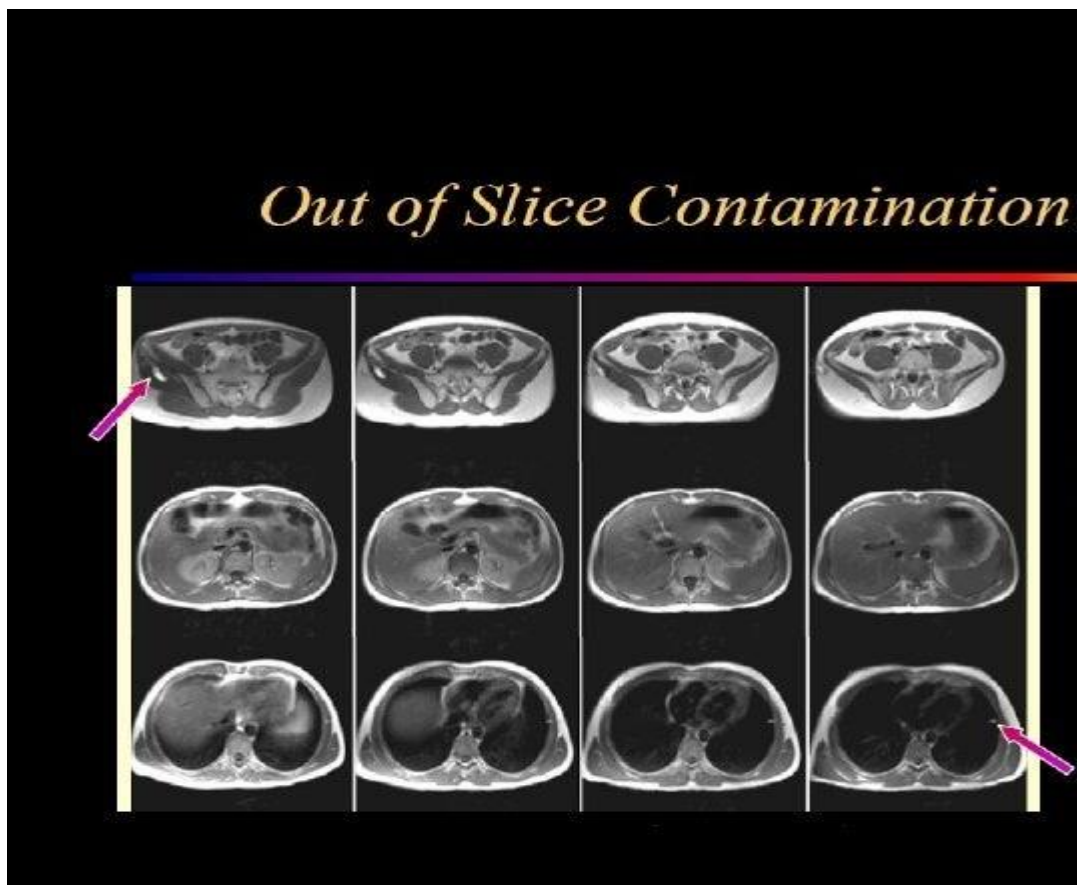
Figure 15 Entry - Slice Phenomenon Artifact

CAUSE - The signal is seen in multiple slices and gets weaker with distance. This artifact was mistaken for thrombosis, with dire consequences. Characteristic positions and, if necessary, the use of gradient echo flow techniques can be used to distinguish entrance slice artifacts and occlusions.

REMEDY - You can use a spatial saturation band before the first slice and after the last slice to remove this artifact.

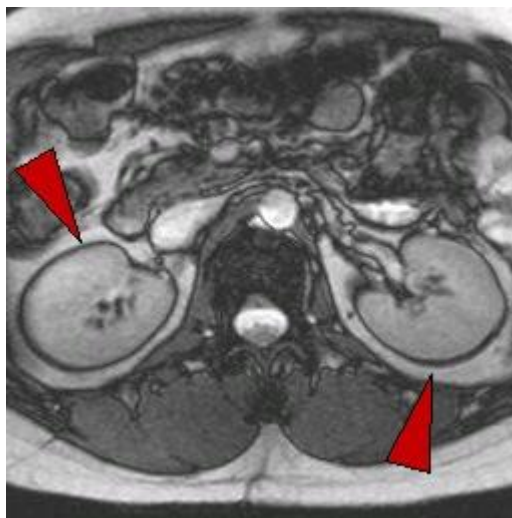
Figure 16 BLACK BOUNDARY ARTIFACT

APPEARANCE - This is the artificially created black line found at the interface between fat and water, such as between muscle and fat. This sharply delineates the boundaries between muscle and fat, giving the image the appearance that someone has outlined these boundaries with ink. While this may be visually appealing, it does not represent anatomy.

CAUSE – Occurs as a result of choosing echo times (TE) in a gradient echo (GE) sequence in which fat and water rotations (located within the same voxel of intersection) cancel each other out of phase. At 1.5 T, a frequency difference of 3.5 ppm between water and saturated fat causes spin cancellation at multiples of 4.5 ms starting at approximately 2.3 ms. This artifact does not occur in spin-echo (SE) sequences because the spins are rephased by a 180degree refocusing gradient.

- Select TEs around 4.5 ms, 9 ms, and 13.6 ms.
- Fat suppression available
- Use SE sequences instead of GE.
