MRI ARTIFACTS

Yogita Janghu

M.Sc. Radio-Imaging technology

SGT University, Gurugram

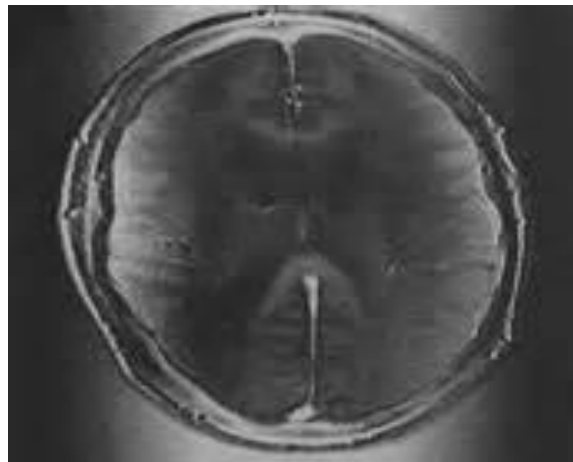
Figure 6 Rf overflow Artifact

CAUSE - this occurs when the signal received by the scanner from the patient is too strong to be accurately digitized using an analog-to-digital converter.

REMEDY– Auto-pre-scan normally adjusts receiver gain to prevent this from happening, but if spurious still exists then receiver gain can be manually reduced. Post-processing methods also exist but can be time consuming.

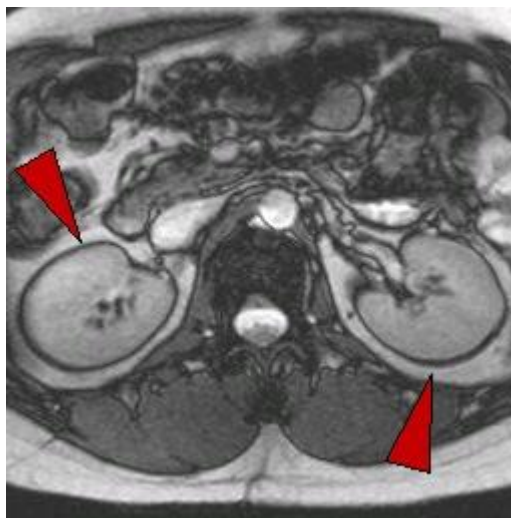
Figure 16 BLACK BOUNDARY ARTIFACT

APPEARANCE - This is the artificially created black line found at the interface between fat and water, such as between muscle and fat. This sharply delineates the boundaries between muscle and fat, giving the image the appearance that someone has outlined these boundaries with ink. While this may be visually appealing, it does not represent anatomy.

CAUSE – Occurs as a result of choosing echo times (TE) in a gradient echo (GE) sequence in which fat and water rotations (located within the same voxel of intersection) cancel each other out of phase. At 1.5 T, a frequency difference of 3.5 ppm between water and saturated fat causes spin cancellation at multiples of 4.5 ms starting at approximately 2.3 ms. This artifact does not occur in spin-echo (SE) sequences because the spins are rephased by a 180degree refocusing gradient.

- Select TEs around 4.5 ms, 9 ms, and 13.6 ms.
- Fat suppression available
- Use SE sequences instead of GE.

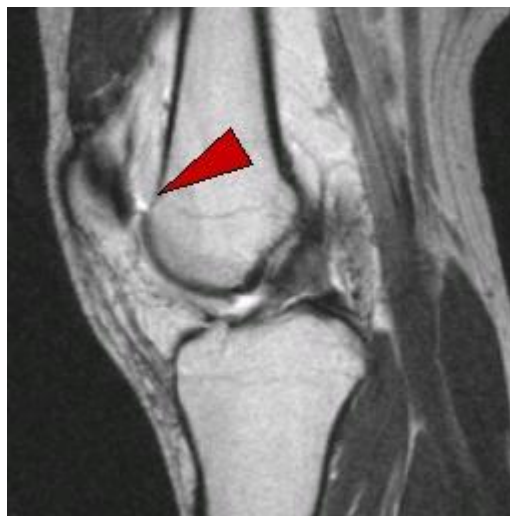
Figure 17 Magic Angle Artifact

This artifact is caused by the special physical properties of fibrous tissue and its interaction with static magnetic fields. Water molecules in contact with structured collagen Fibers (tendons, ligaments, nerves, menisci, etc.) exhibit dipolar interactions that shorten the T2 relaxation time. The extent of these interactions varies with the angle of the Fiber with respect to the field axis B^0 . Maximum at angles 0° and 90° , minimum at 55° .

It is maximum for relatively short TEs (around T2) and decreases with longer TEs. The relative hypersignal change is angle dependent and increases gradually between 0° and 55° . The magic angle has virtually no effect on T1 relaxation time. Therefore, the T1 weighting sequence is less affected.
