Investigation on efficacy of admixtures in repairing and improving the characteristics of concrete cylinders.

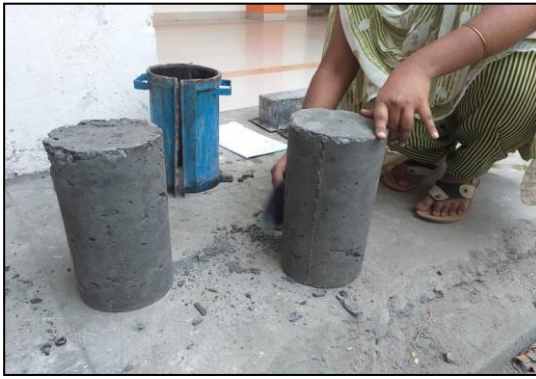
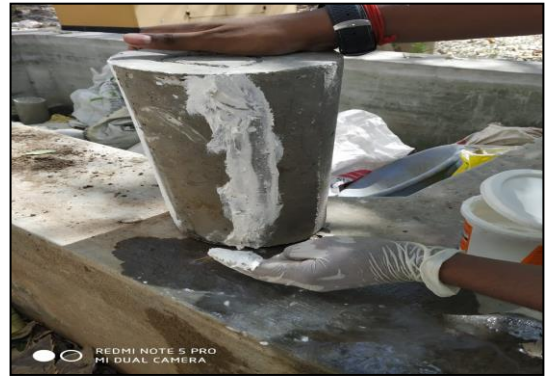
Figure2. Cylinder repairing process

After the gathering of the materials, a preliminary cement, sand, and gravel test was carried out. For cement, tests on consistency, setting time, and specific gravity were performed. Both aggregates underwent a sieve analysis test, and the fineness modulus was determined. Bulk modulus testing were conducted in addition to measurements like specific gravity. IS 10262-2009 was used for mix proportioning. Use is made of M25 grade concrete in a mix ratio of 1:1.62:2.57:0.4. 6 150 mm-sized cubes and 12 150 mm-diameter cylinders were cast together and let to cure. At 7, 14, and 28 days after curing, cylinders and cubes are tested for compressive strength and split tensile strength. The cracked cylinders that were put through testing are fixed. Initially, a crack measuring equipment was used to gauge the crack's depth. Later, the first crack propagation for the first day was observed and its length of propagation for the seventh day was compared. Following this, three cylinders' cracks were sealed using Fly ash mixed with water after GGBS powder was formed into a paste by adding water and then injected into the cracks. The last three cylinders were repaired using Crack X paste, three cylinders, and RoffShotcrete Acrylic Polymer. Later, using a compression testing machine, the split tensile test was performed after being let to dry for 24 hours.

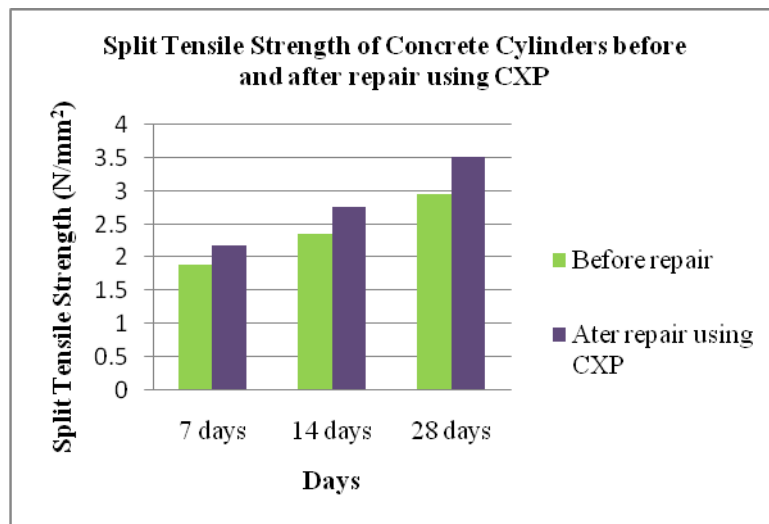
D. Figure 6 displays the Split Tensile Strength of concrete cylinders before and after repair with CXP.

Figure 6. Concrete cylinders' split tensile strength before and after CXP repair

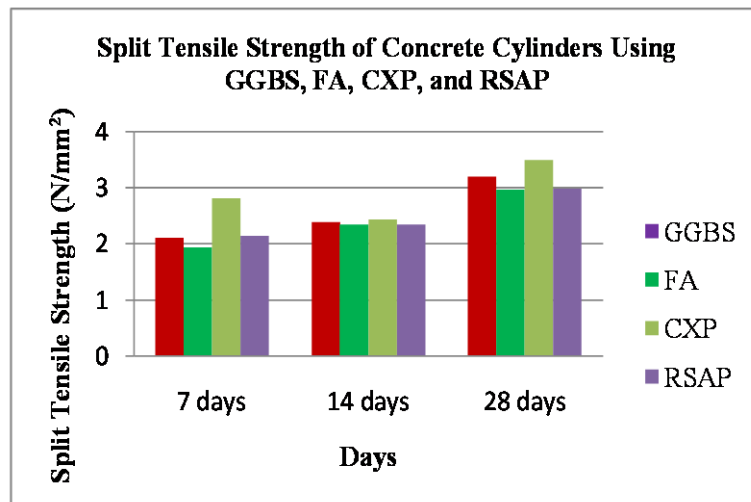
Comparative research on the effectiveness of chemical and mineral admixtures is presented. Figure 8 compares and graphically displays the split tensile strength of concrete cylinders repaired with GGBS, FA, CXP, and RSAP.

Figure 8. Split Tensile Strength of Concrete Cylinders using GGBS, FA, CXP & RSAP

- To fix cracks in concrete cylinders, two chemical admixtures, Crack X Paste (CXP) and RoffShotcrete Acrylic Polymer (RSAP), and two mineral admixtures, Granulated Blast Furnace Slag (GGBS), Fly ash of F Class (FA), are employed. In this inquiry, M 25 grade concrete is used in the design. The desired strength has been attained.
- The big straight-line cracks that had been repaired did not reopen, and the repaired cylinders failed as a result of the emergence of fresh significant straight-line cracks. When repair efforts include retrofitting, new cracks can be prevented.
- When GGBS is used as an additive, the split tensile strength of concrete cylinders has improved, but when FA is used, there is only a little or marginal increase. GGBS functions effectively when used with

the two mineral admixtures that were chosen. When CXP is used, the split tensile strength of concrete cylinders has risen, but when RSAP is used, it does not perform as well as CXP. The efficiency of Crack X Paste is superior than that of the other two chemical admixtures. These cheap, efficient admixtures may be used to restore concrete structures at any state of degradation.
